# Technical Bulletin

TSB No. TS 07 03014R2

**SUBJECT: TIMING CHAIN TENSIONER**
**MODEL(S): GRAND VITARA/XL-7**
**YEAR: 1999-CERTAIN 2002**

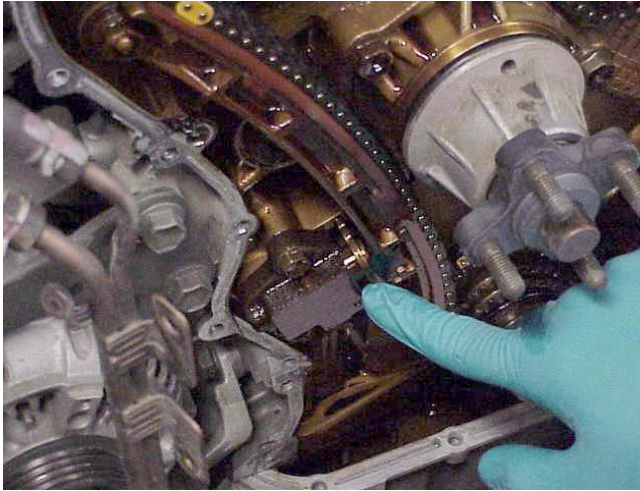
### TENSIONER ADJUSTER ASSEMBLY (#1) LOWER RIGHT FRONT SIDE OF ENGINE

**CONDITION:** Loud chain rattling noise from right front of engine behind the timing cover. Noise is usually loudest when engine is started cold.

**CAUSE:** Number 1 Timing Chain Tensioner not adjusting properly.

**CORRECTION:** Remove front timing chain cover and replace ONLY the Number 1 Timing Chain Tensioner (Part Number 12831-85FA7 or latest part number). For removal and installation procedures for the Number 1 Timing Chain Tensioner, refer to the Engine Mechanical Section of the applicable Suzuki Service Manual. Reseal front timing chain cover as outlined in TSB 06 02244R2.

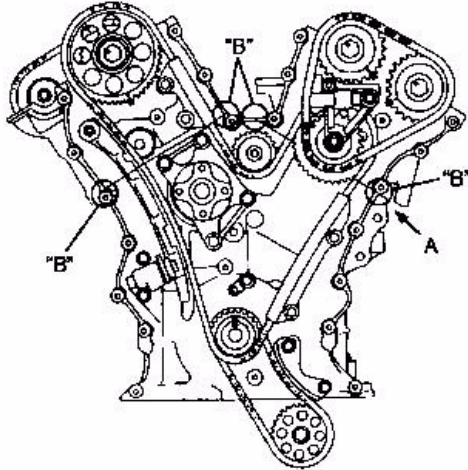
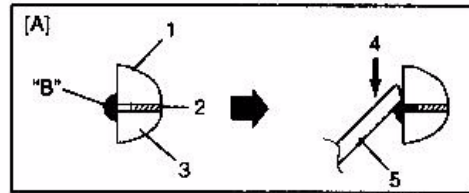
1. Cylinder Head
  2. Cylinder Head Gasket
  3. Cylinder Block
  4. Rub Into
  5. Plastic Scraper or Equivalent
- [A]: View A

**NOTE: Failure to perform this step will result in oil weepage/seepage that will migrate down the front side of the engine block. This may appear and be misdiagnosed as a crankshaft oil seal leak.**

3. Apply sealant "B": Suzuki Bond 1207B (#99104-31140) to the mating surfaces of the cylinder heads and cylinder block as shown. Use a plastic scraper as a jig to force the sealer into the air gap formed by the cylinder head, block and head gasket as shown in call-out "A" below. There are four areas "B" where this must be performed.
